T-2 Kärevere Junction Traffic Safety Audit

April 2005
Maanteeamet

T-2 Kärevere junction, traffic safety audit

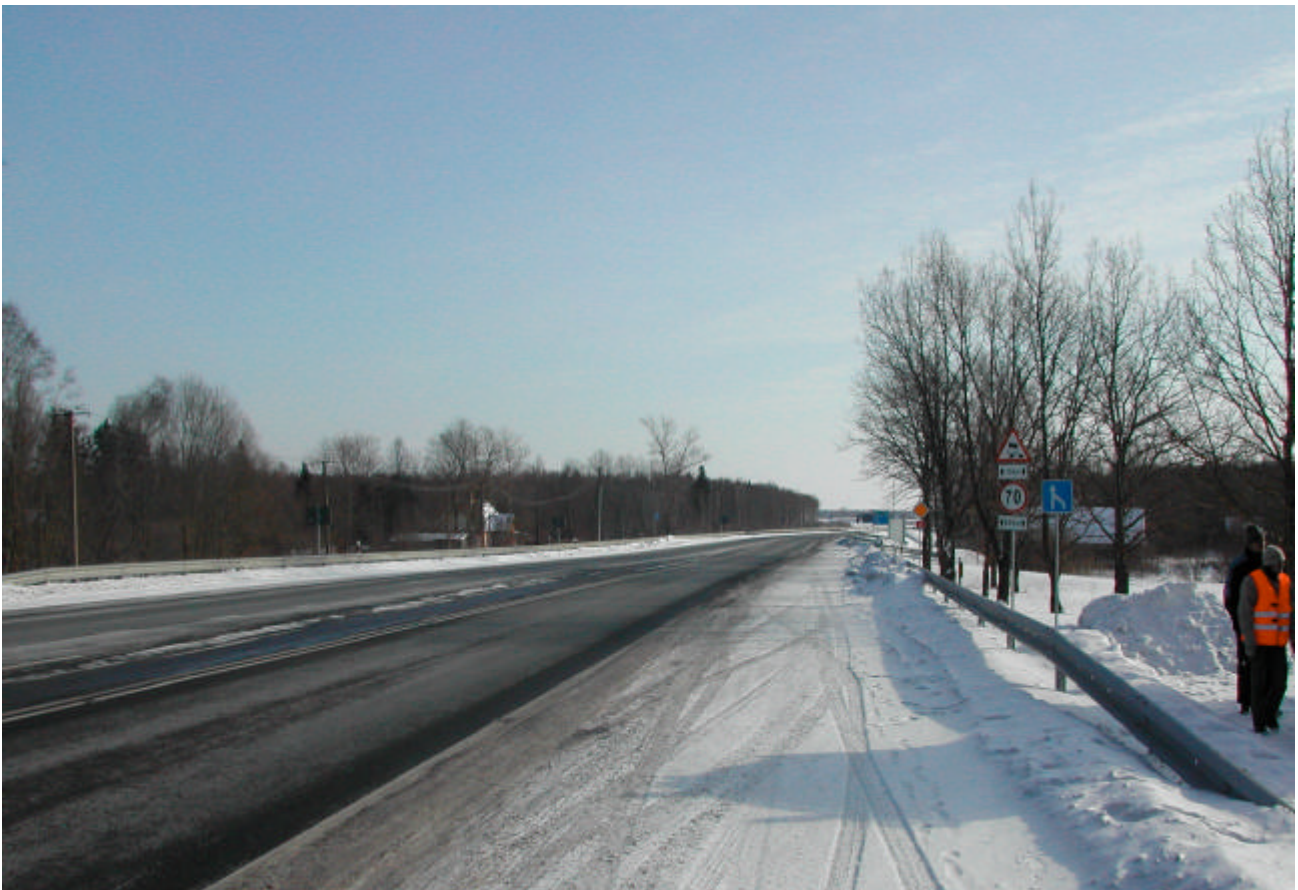
In 12 seconds an approaching car going 70 km/h moves 230 m, and a car in 100 km/h (which is no underestimation of current speeds) 330 m. A pedestrian waiting to cross the road by the restaurant can observe the approaching vehicles over a distance of ca 250 m in both directions. The curve on T-2 in connection with the trees, signs and shelter hides the vehicles. The crossing is made even more difficult by the heavy traffic volume, that only provides short laps i the traffic stream.

T-2 towards Tartu. Visibility is limited by trees, signs and shelter

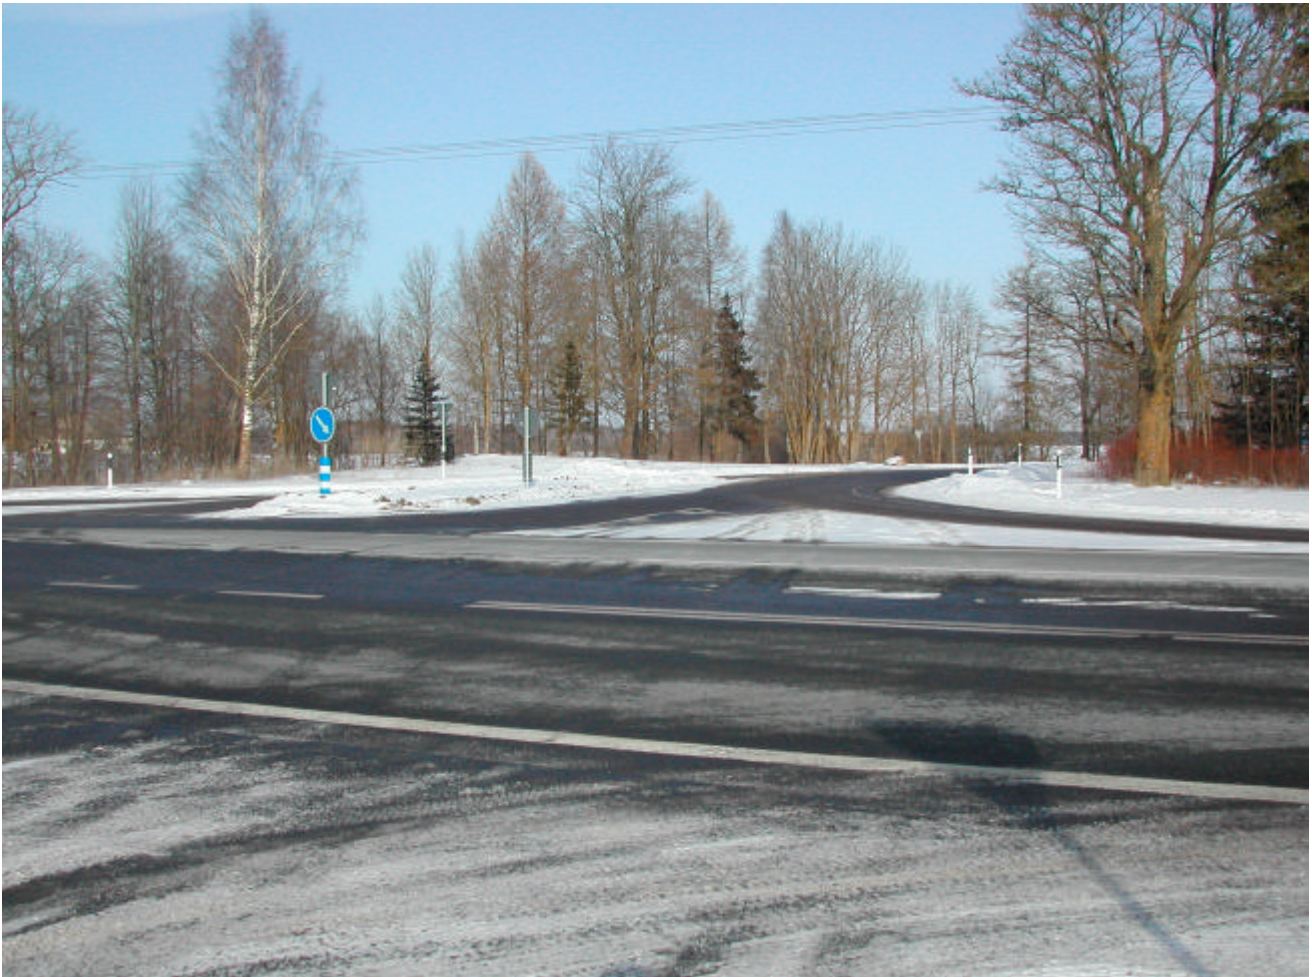
T-41 Kärtna road.

The large number of lanes makes it difficult to choose the right one, especially when road markings are worn or there is snow. Furthermore the junction is in a long curve which requires good observing by the driver to keep in lane. On site there are marks of single accidents with turning vehicles (crashed guard rail). These accidents, which fortunately are less severe, are a result of too high turning velocities. This is probably due to the design, with large space in connection with the additional turning lane with isle by the centre isle, which then suddenly narrows to a normal lane on the Kärkna road. Turning velocities can also be too high because of the wide road which generally tends to increase speed.

The following measures deal with the above mentioned problem:

- Lighting of the road
- Separating opponent traffic directions (barrier, kerb)
- Increasing of lanes (are all lanes needed?)
- Sufficient marking of lanes (portals with lane signs, markings, marking nails)
- Support for adjusting speed (barriers, kerbs, isles)
