T-39 Kärkna Junction Traffic Safety Audit

April 2005
Maanteeamet

Oy Talentek Ab

T-39 Kärkna junction, traffic safety audit

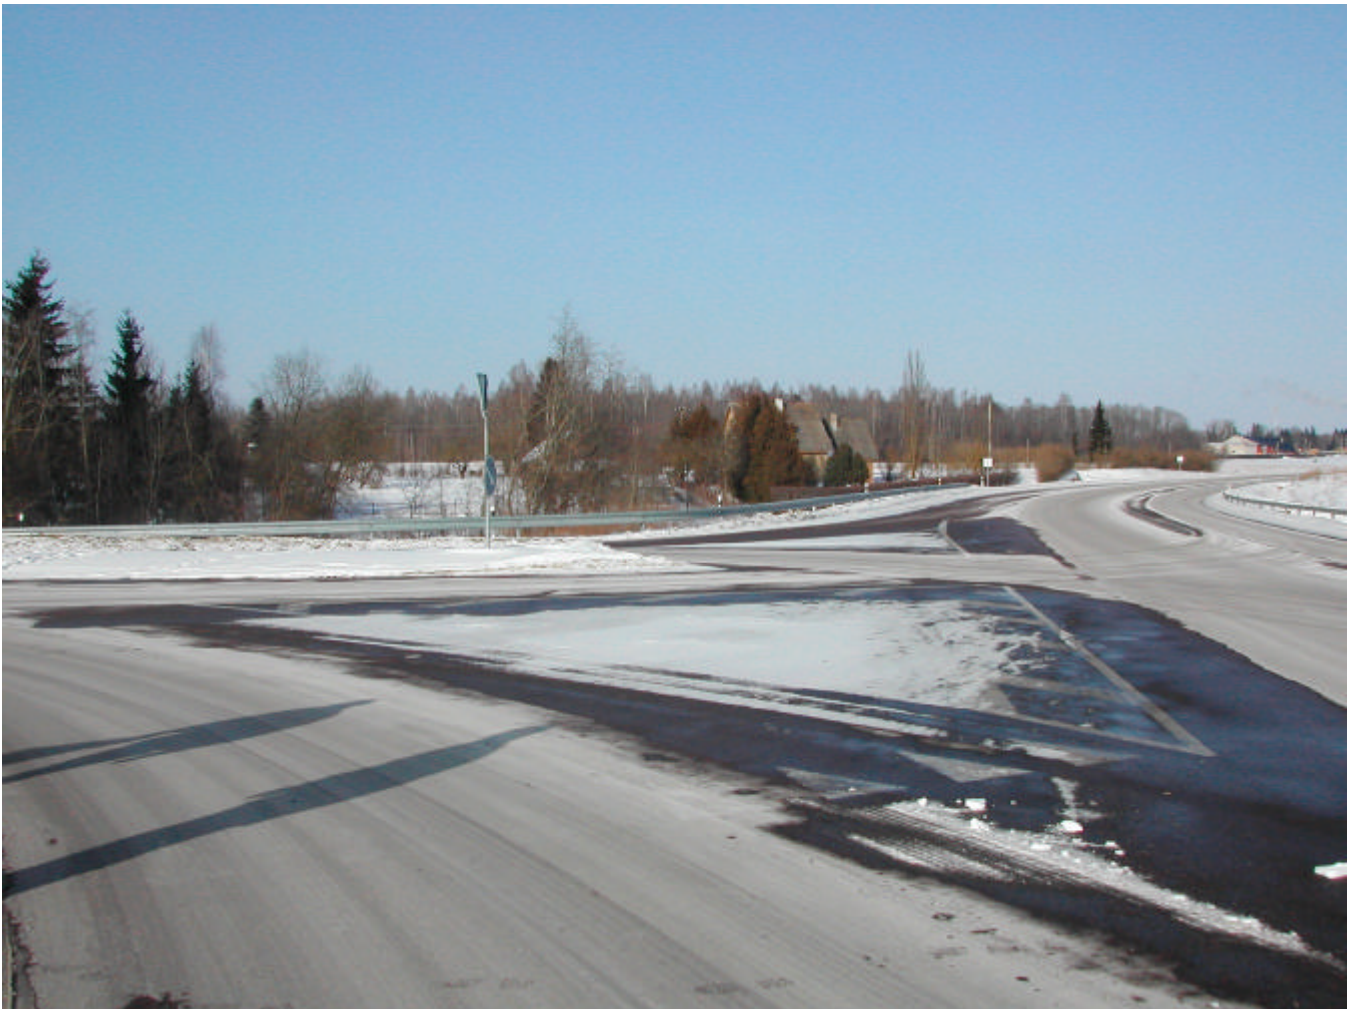
For vehicles turning left from the T-41 there is the common problem with a road connecting to the outside of a curve, where as in this case the outer side is almost 0,4 m above the inner side, and the road surface seems to run away.

Alter the give way sign to STOP on T-41. This should reduce speed of those turning left.

Bring the kerb of the middle isle closer to the T-39. It should be possible to bring about 2,5 meters closer without causing hazard to passing traffic on T-39. The end of the kerb is a good fix point for left turning traffic, and forces the driver to make a sharper bend
