T-39 Kärkna Junction Traffic Safety Audit

April 2005
Maanteeamet

Oy Talentek Ab

T-39 Kärkna junction, traffic safety audit

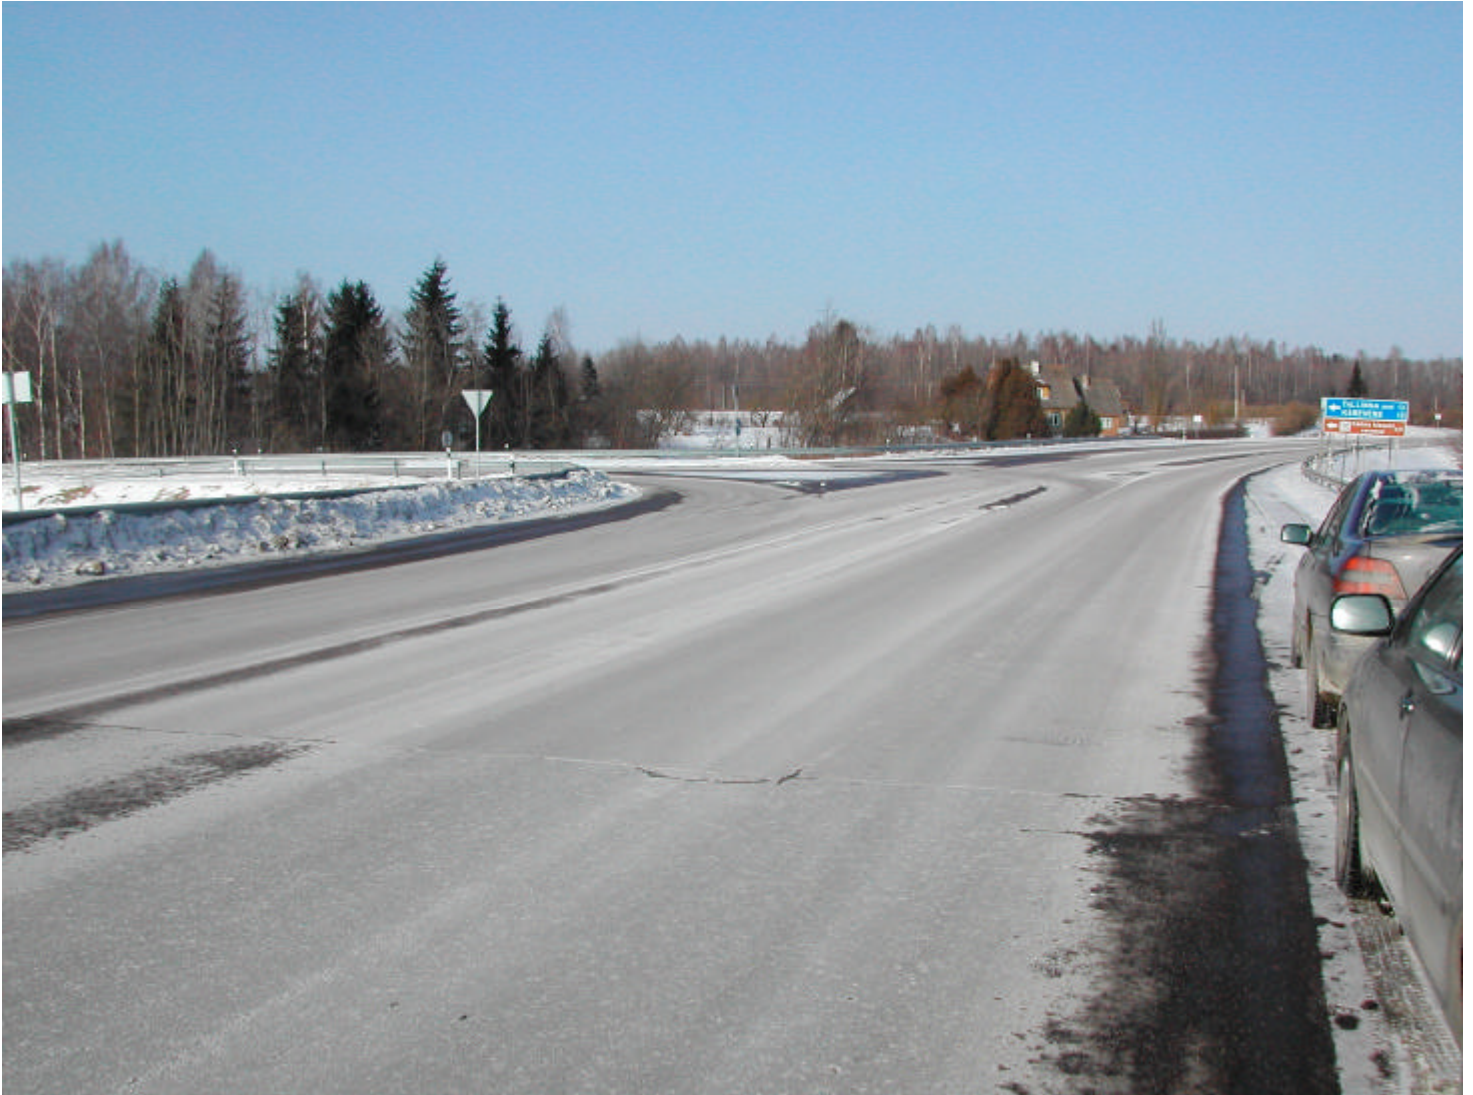
The Kärkna junction on T-39 is situated in a large curve to the left in direction to Tartu. The elevation is uphill in the same direction. The junction between the Tartu-Jogeva T-39 road and T-41 secondary road is a three road junction.

The T-39 road has lanes for turning traffic to left from Tartu and right from Jogeva. The directions are divided by road markings. The T-41 has an middle isle with kerbs, and painted isles dividing turning traffic.

There are barriers on all sides. The bridge over Amme river is close to the junction towards Tartu.

The lay-out of the junction seems to be too loose with too few references for the driver.

Bring the kerb of the middle isle closer to the T-39. It should be possible to bring about 2,5 meters closer without causing hazard to passing traffic on T-39. The end of the kerb is a good fix point for left turning traffic, and forces the driver to make a sharper bend
